(6) National Dam Safety Program. N.J. No Name Dam Number 58 (NJ00653), Wallkill River Basin, Tributary to Papakating Creek, Sussex County, New Jersey. Phase I Inspection Report.

NEW JERSEY NO NAME DAM NO. 58 (NJ00653)

PHASE I REPORT
NATIONAL DAM INSPECTION PROGRAM

Name of Dam N.J. No Name Dam No. 58 Fed ID# NJ 00653

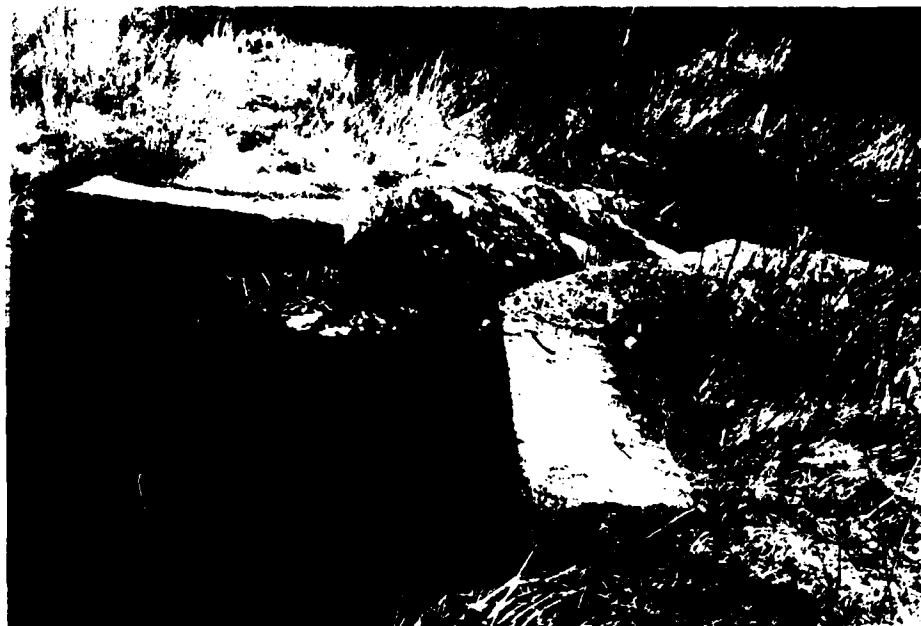
The spillway consists of a small concrete weir located about 300 feet to the north of the left abutment. Minor spalling of the concrete wingwalls was noted and the downstream ends of the sidewalls were slightly undercut. A layer of coarse sand and gravel has built up in front of the concrete sill of the weir to an elevation slightly higher than the sill itself. The opening of the weir is 30 percent constricted by a pile of earth. It is apparent that someone recently dumped earth across the entire weir in order to block the spillway and raise the lake surface elevation. The makeshift earth dam has been breached and the water elevation has returned to the normal pool elevation. The earth remaining in the spillway channel is considered inconsequential since the next large storm will clear the spillway completely.

VISUAL EXAMINATION OF	OBSERVATIONS	REMARKS OR RECOMMENDATIONS
CONCRETE WEIR	Fair condition. Light spalling on edges of the wingwalls. Slight undercutting of downstream sidewalls. Spillway was filled with earth in attempt to raise water elevation. Earth was breached but weir is still partially blocked.	Concrete deterioration should be repaired and undercut areas refilled. Earth remaining in spillway should be cleared.
APPROACH CHANNEL	Sand and gravel lake bottom between wingwalls. Partially constricted by earth.	Earth should be removed.
DISCHARGE CHANNEL	Clear natural channel.	No constrictions observed
BRIDGE AND PIERS	None

March, 1981
Upstream View of Spillway 300' North of Dam

d. The earth in the spillway channel should be removed, the deteriorated concrete repaired and the undercut portions of the sidewalls refilled.
